COLORADO
Division of Water Resources
Department of Natural Resources
Dam Safety Branch

When replying, please refer to:
TURNER DAM, DAMID 300113
Water Division 7, Water District 30

SUBJECT: 2021 Engineers Inspection Report

Turner Dam

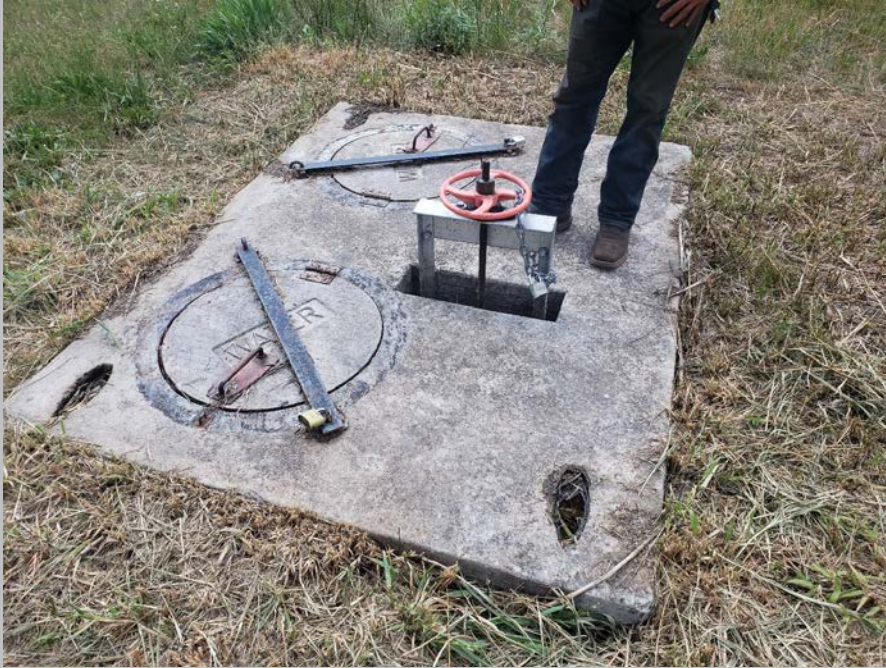
Flume Vault in Spillway Channel

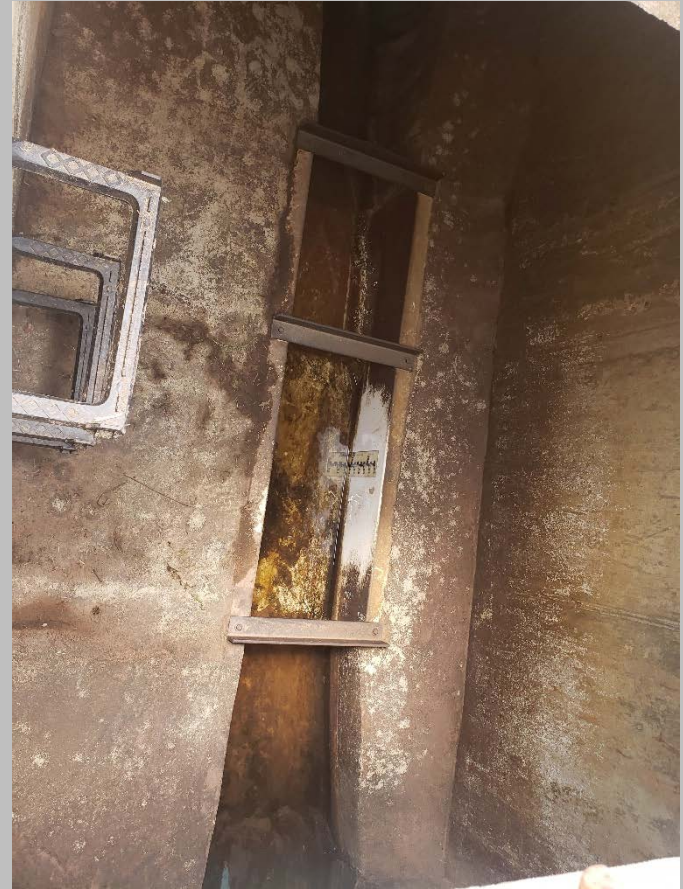
Parshall Flume in Vault

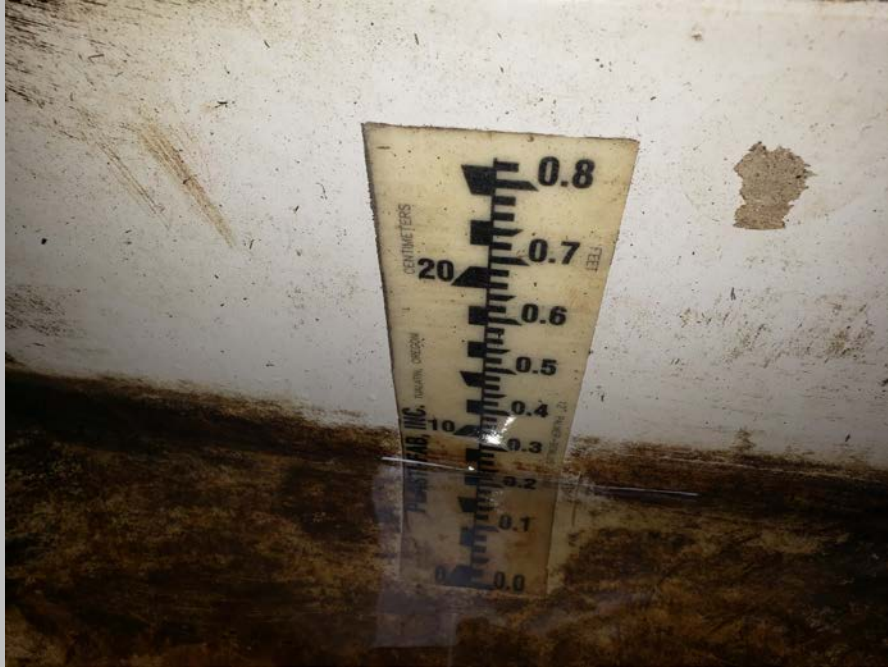
Stage on Flume = 0.24'

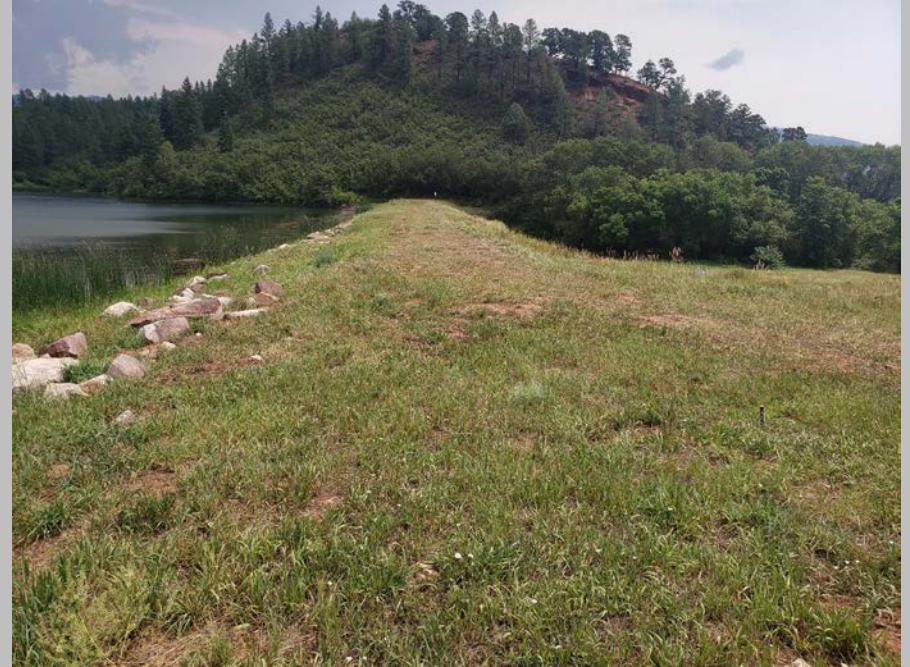
The crest has a good short grass cover and no vehicular access. No concerns noted.

Crest from Right End of Dam

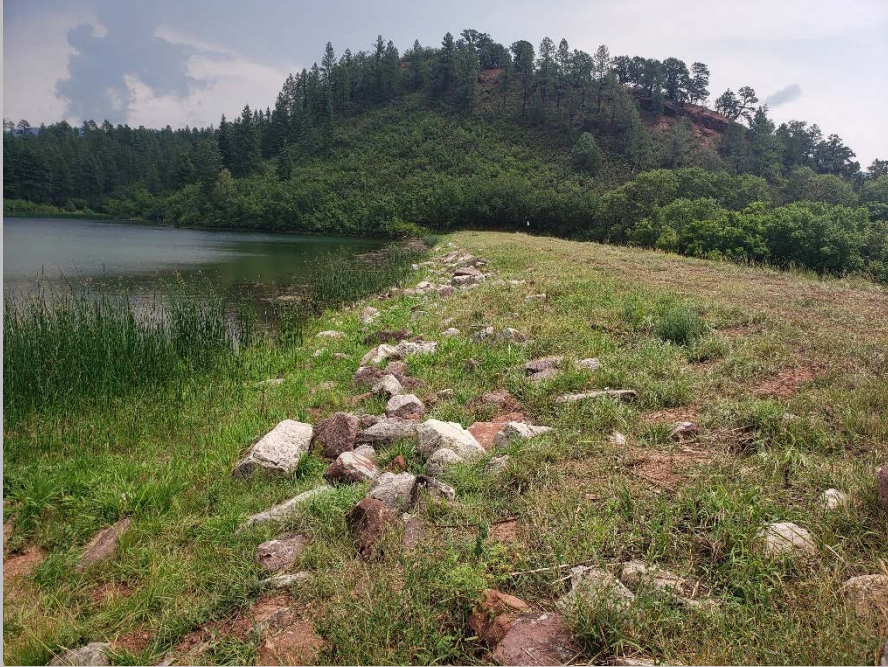
The upstream slope appears in good condition. Undesirable vegetation has been removed and the slope has a good short grass cover. There are some rushes along the normal water surface. They do not obscure the slope or cause any other issues. Riprap is performing well; no signs of erosion.

Upstream Slope from Right End of Dam

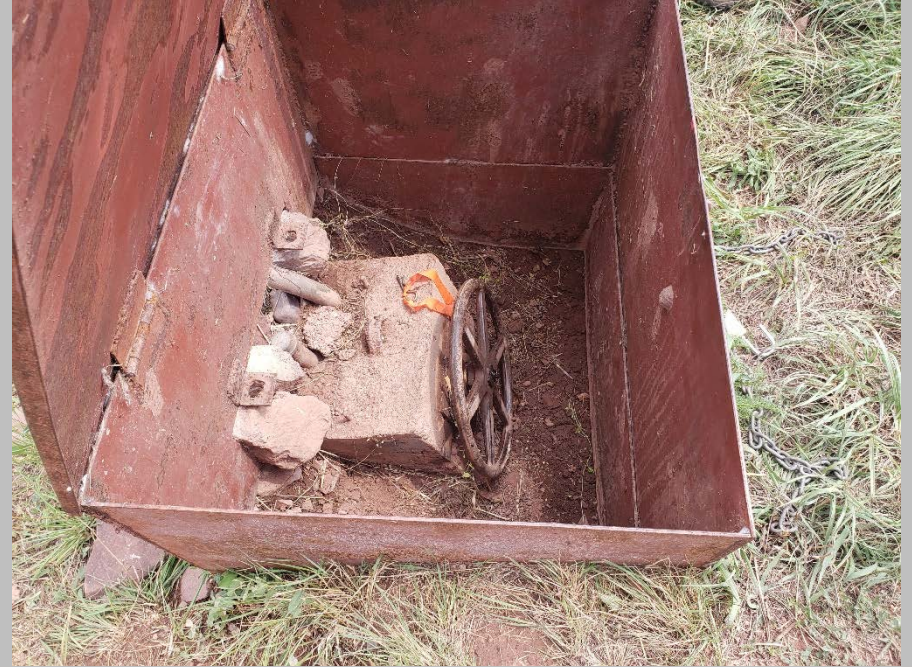
Outlet Operator

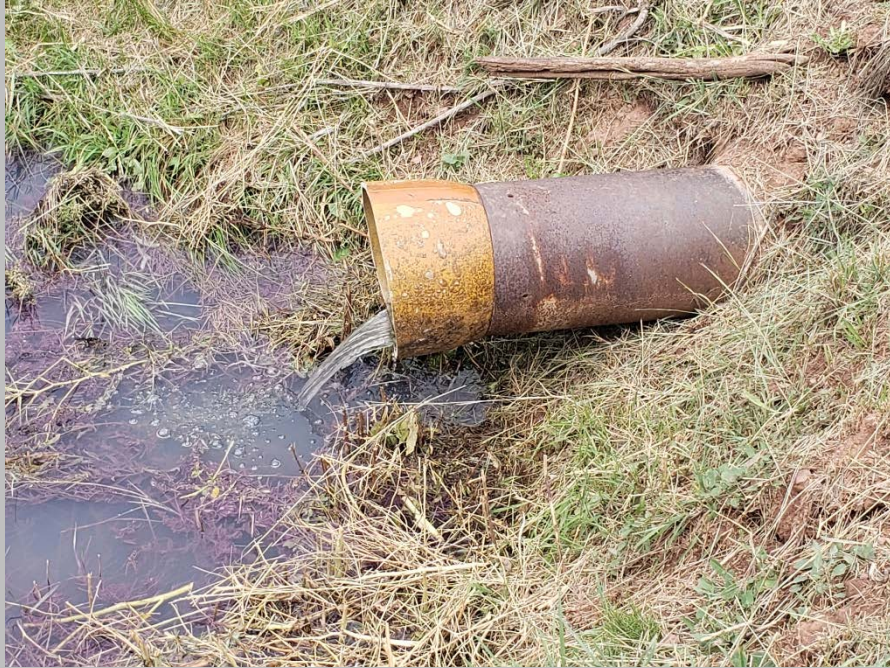
(45) The outlet was operated to near full stroke during the inspection in an attempt to dislodge any potential obstructions in the intake. (48) Gate leakage had increased notably over historic performance since the conduit was lined in 2013. Historic leakage has been in the four gallons per minute range. At the time of the inspection, leakage was estimated at 15 gpm. After exercising the gate, leakage remained well above historic values. (120) The outlet has not been video inspected since just after the CIPP liner was installed in 2013. It would be advisable to perform a video inspection of the conduit, particularly at the gate to determine the cause of the increased leakage. A wet inspection/gate adjustment may be warranted as well.

CIPP Lined WSP Outlet Conduit – Note Increased Gate Leakage

8/16/2021 - Perform Internal Inspection to Investigate Cause of Increased Leakage

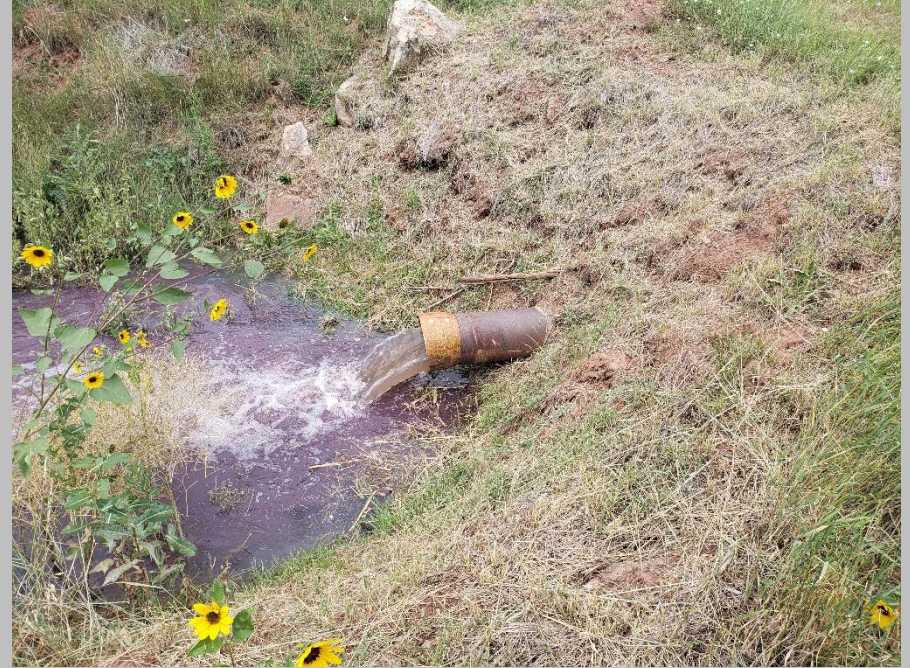
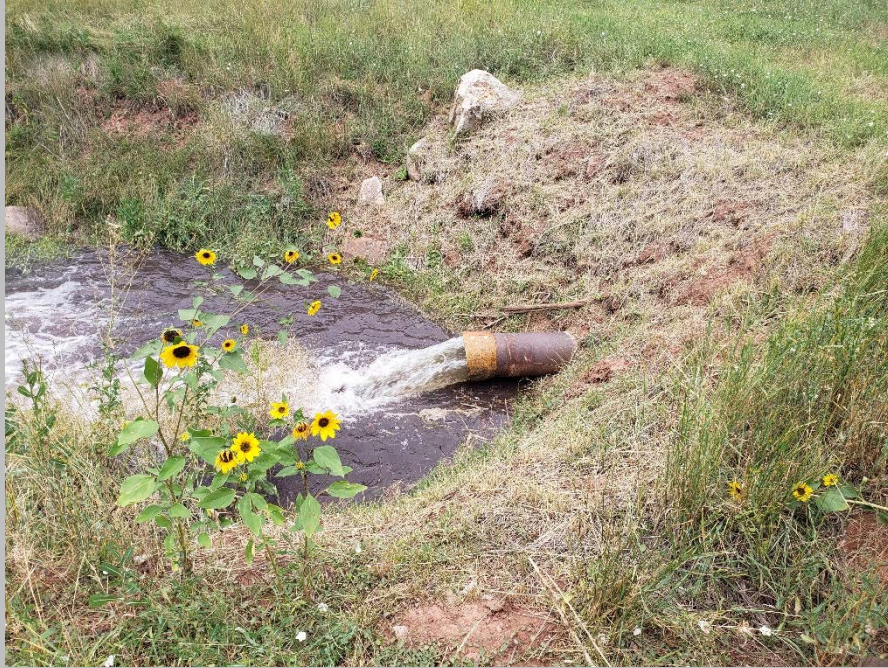
Exercising the Outlet

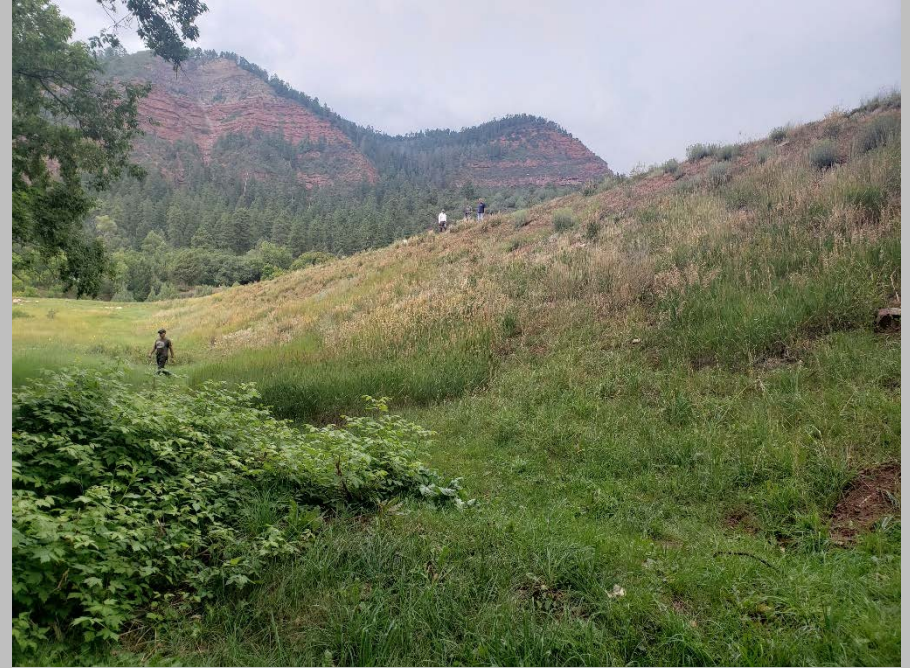
The embankment exhibits good seepage control. The toe area and valley floor below the dam area firm and dry as are both groins. The dam has no internal drains.

Toe Area from Near Left End of Embankment

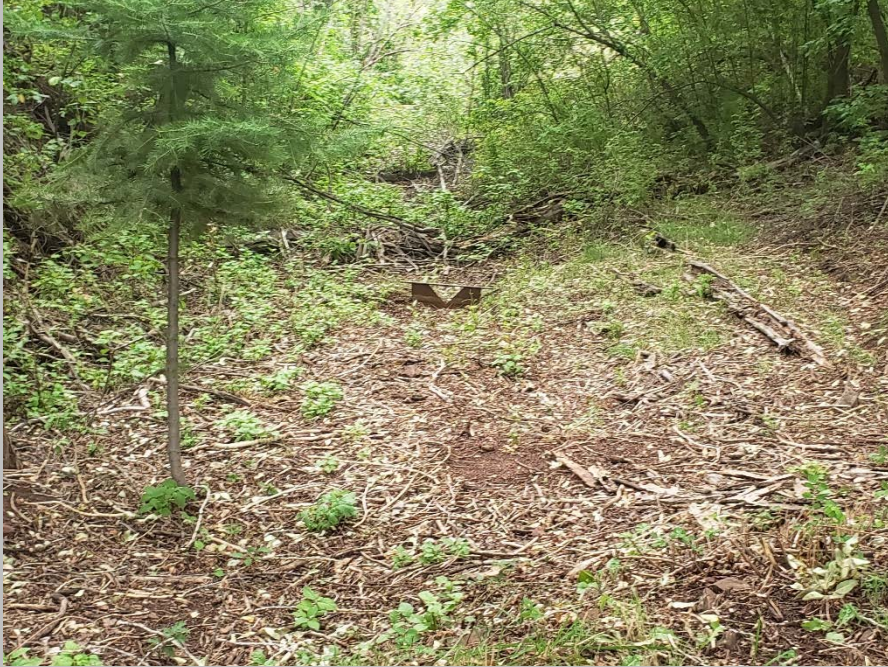
The Loneliest Flume in La Plata County
