COLORADO
Division of Water Resources
Department of Natural Resources
Dam Safety Branch

When replying, please refer to:
TURNER DAM, DAMID 300113
Water Division 7, Water District 30

SUBJECT: 2024 Engineers Inspection Report

ENGINEER'S INSPECTION REPORT

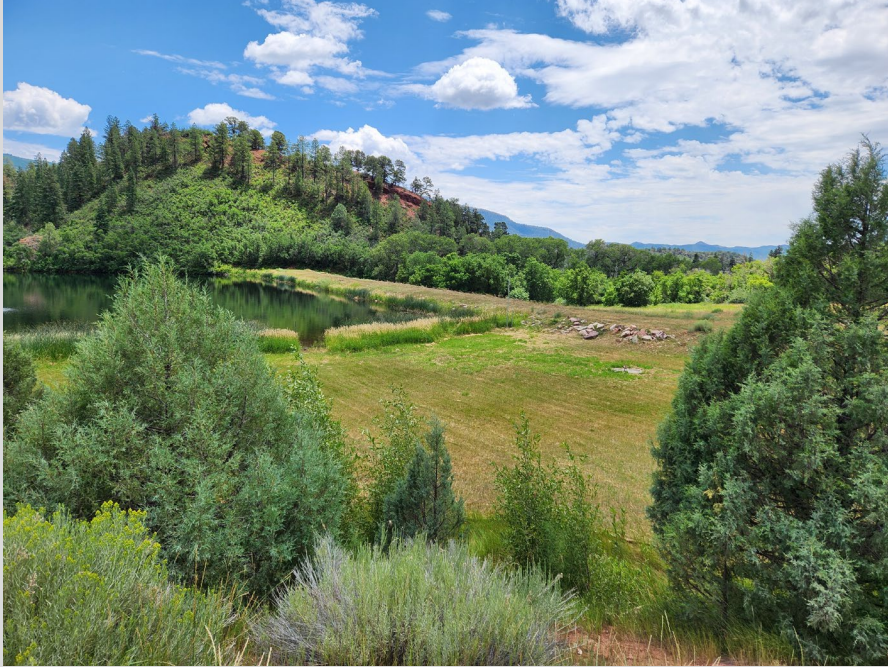
Spillway Channel – Upstream End

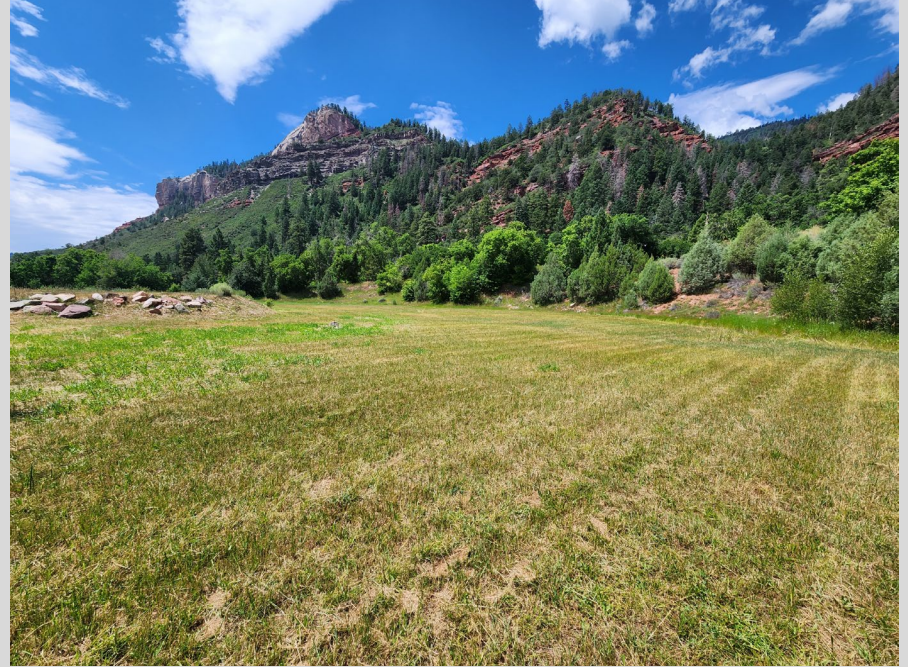
Spillway has good geometry and is maintained free of obstructions. The channel was recently mowed prior to the inspection and has the appearance of a city park.

Spillway Channel – Looking Downstream

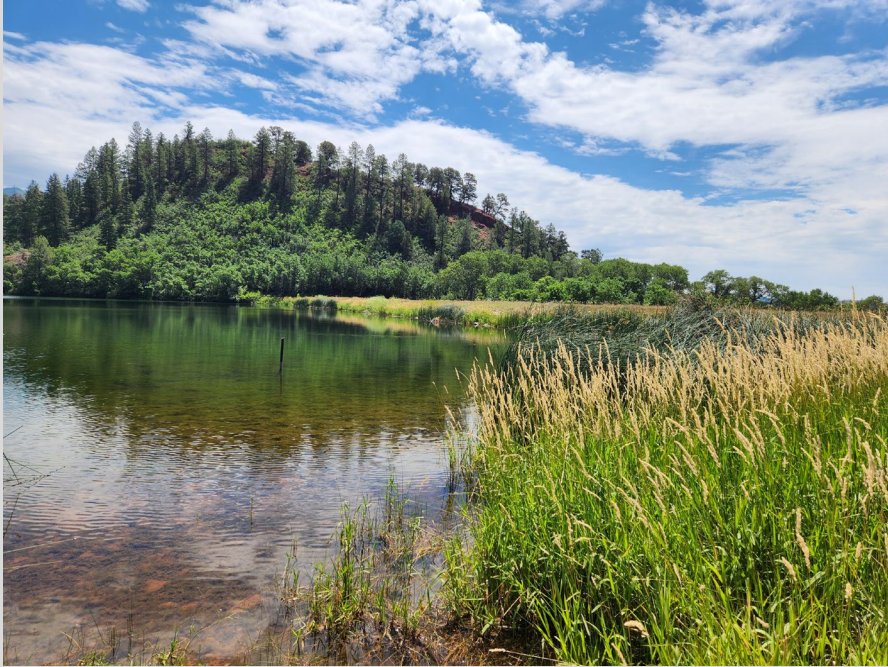
Looking at Upstream Slope from Spillway

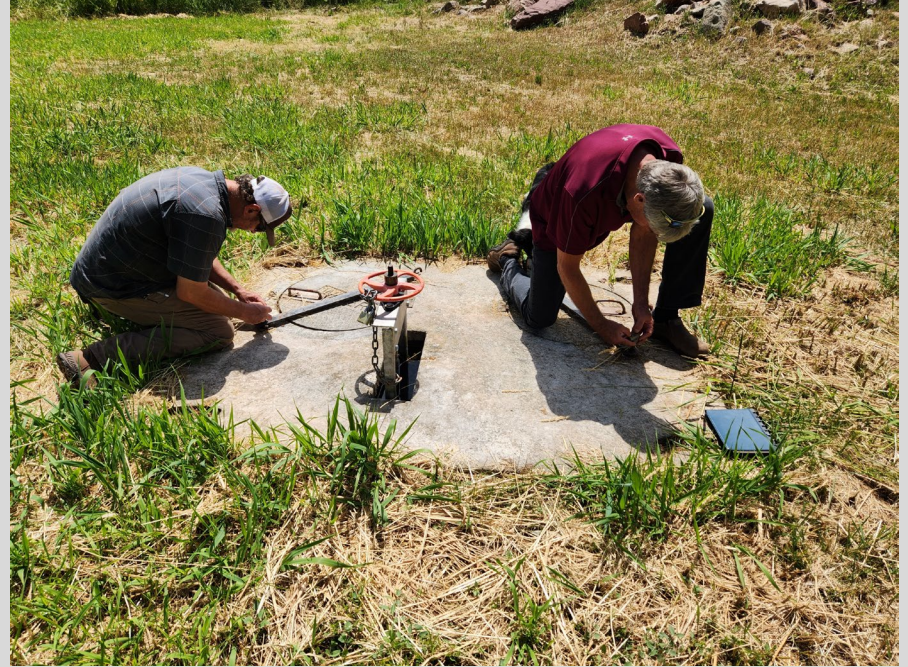
Vault in Spillway Channel

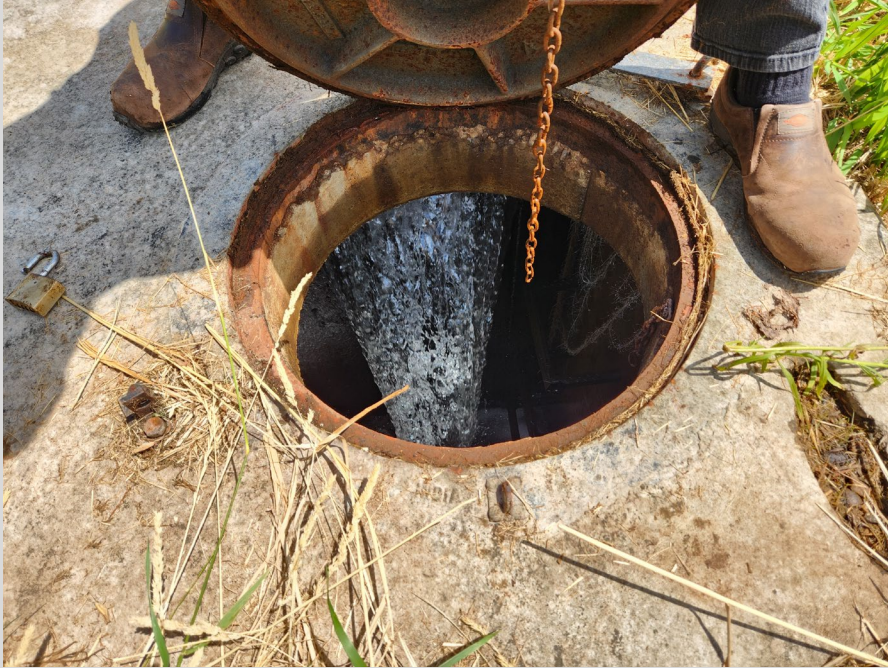
Flow Over Gate Inside Vault

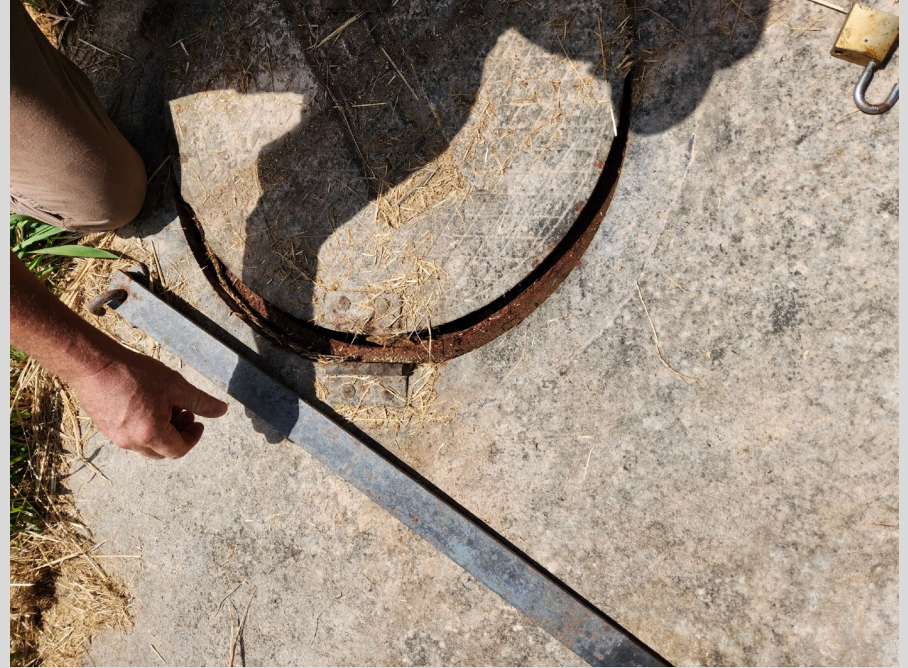
Flume Vault

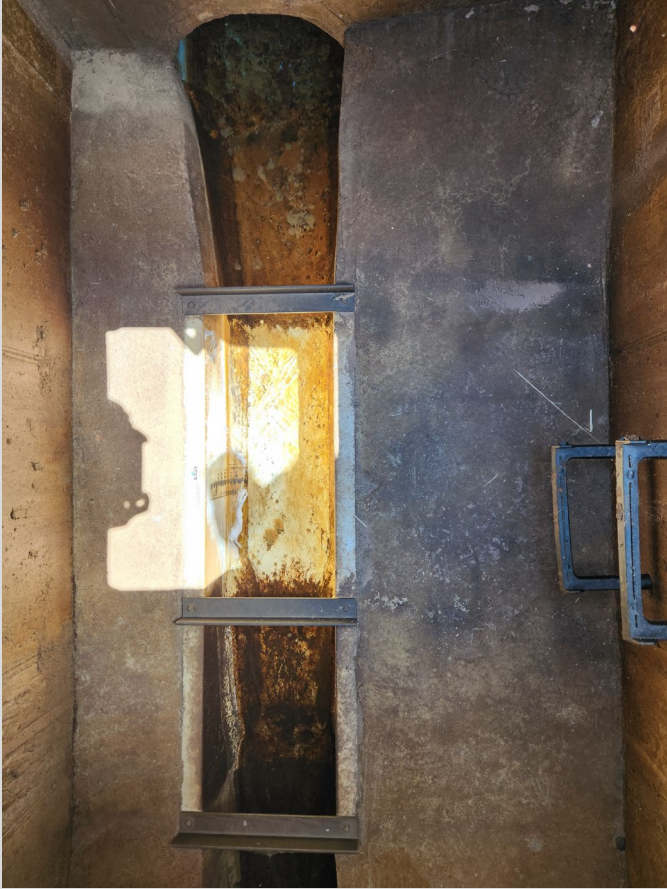
Flume Inside Vault

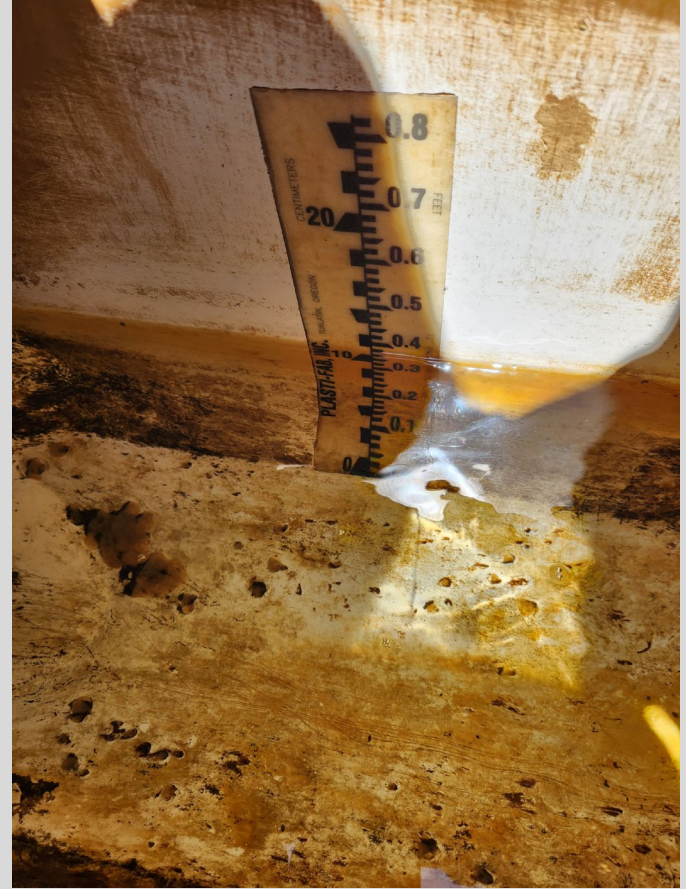
Staff Gage on Flume

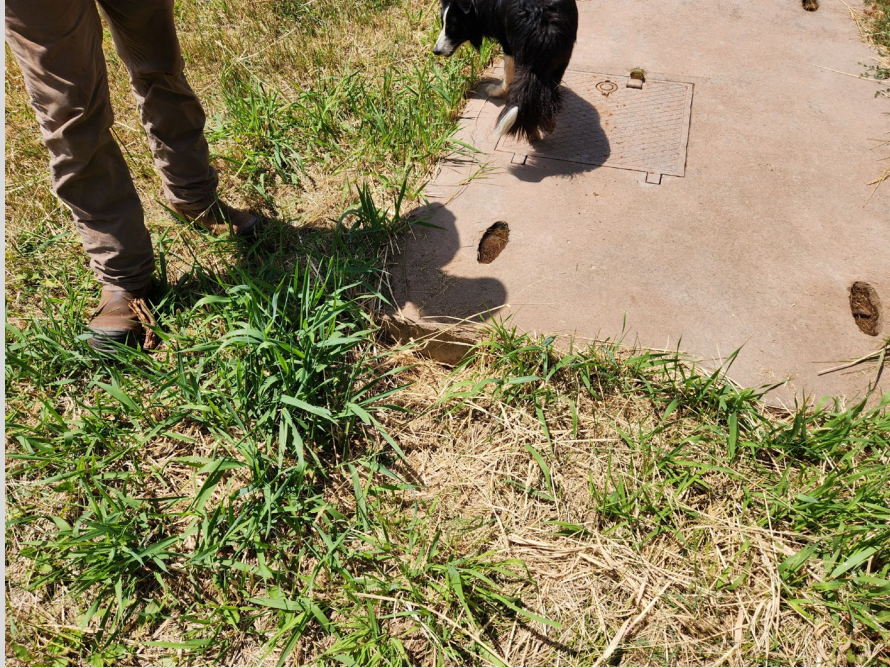
Lid of Vault

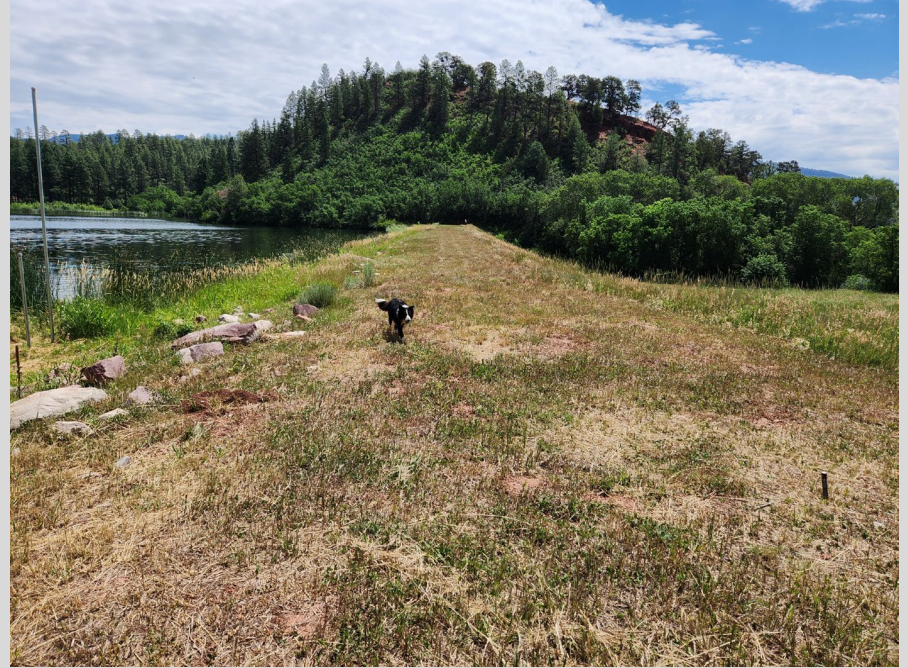
Crest from Right End

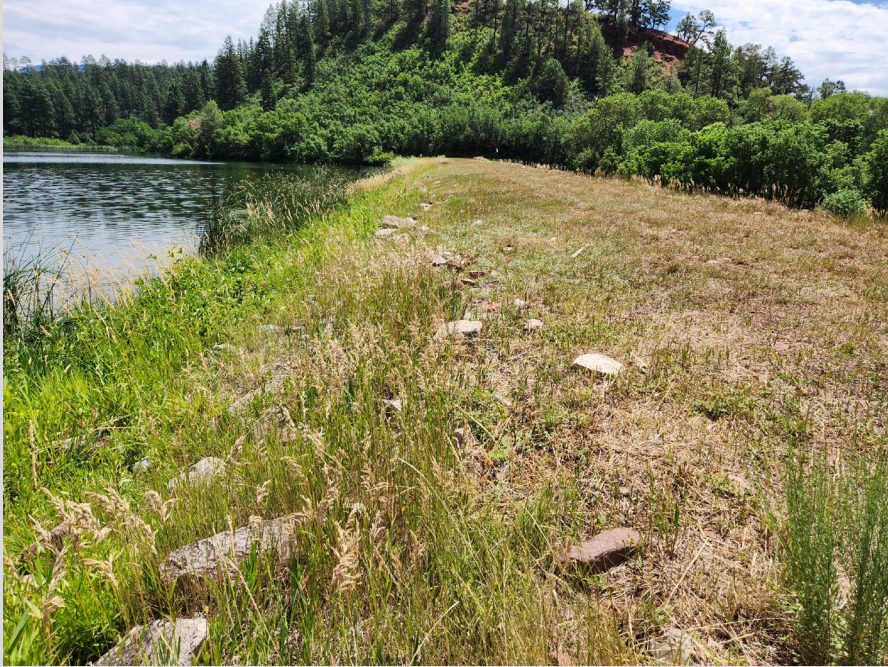
Upstream Slope and Crest

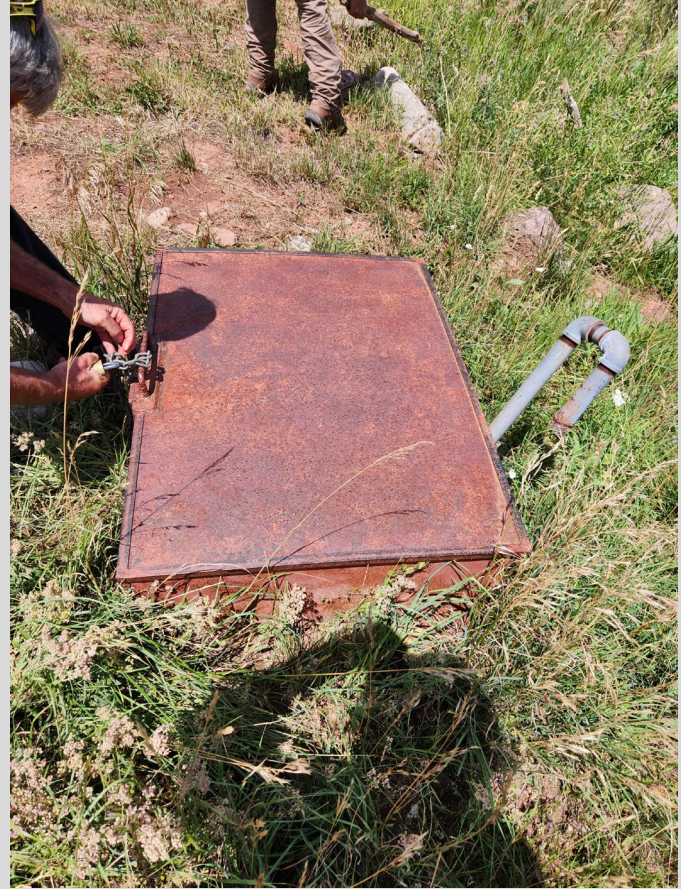
Outlet Operator Vault

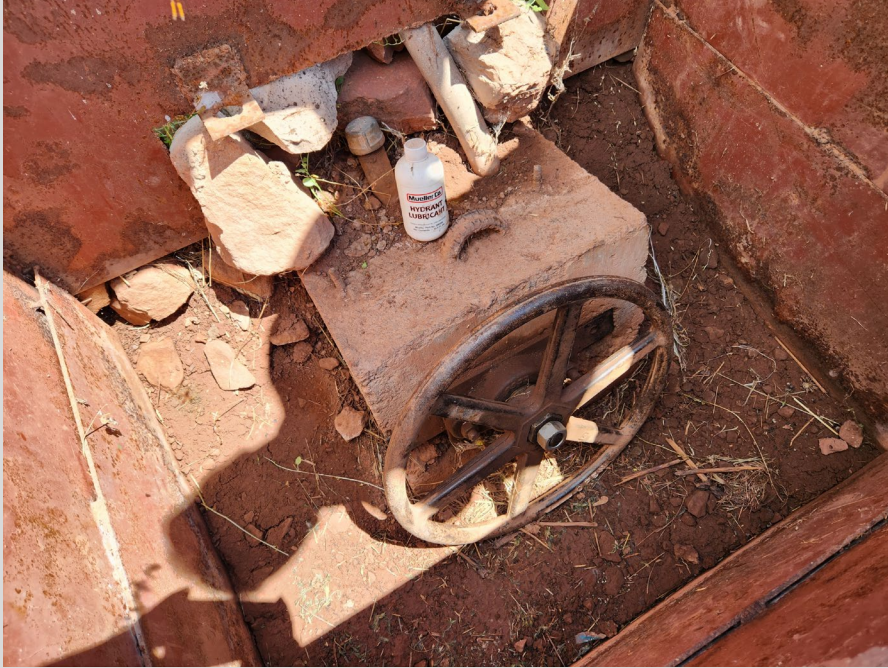
Outlet Operator

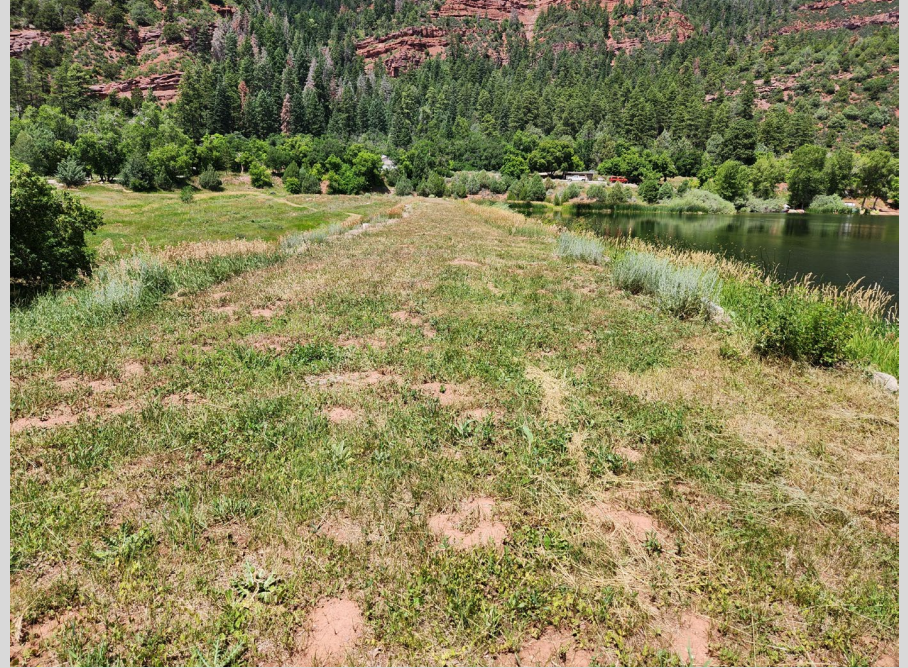
Crest from Left End

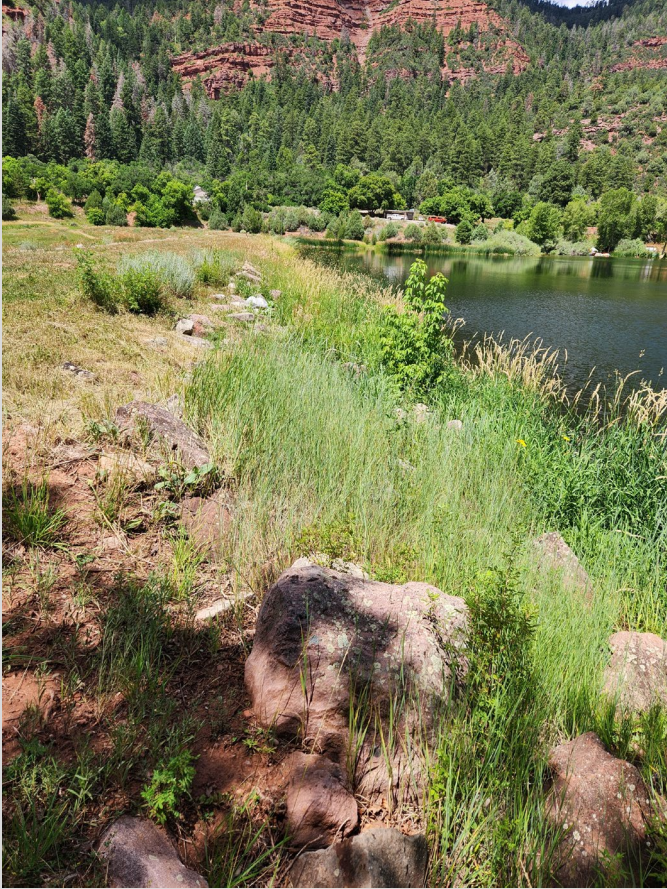
Upstream Slope from Left End

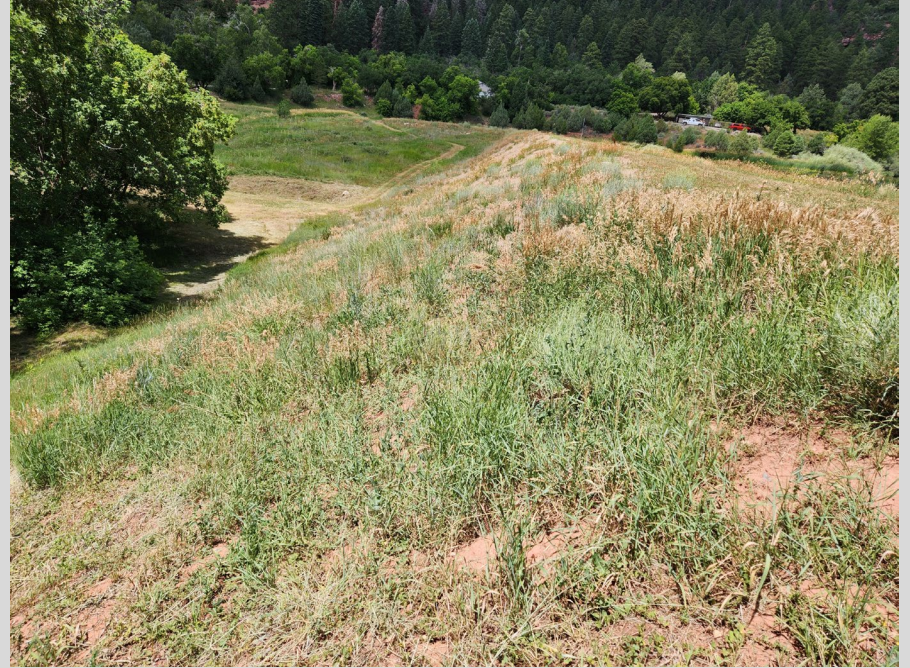
Vegetative cover appears slightly improved this year. No concerning erosion noted.

Left Groin and Downstream Slope

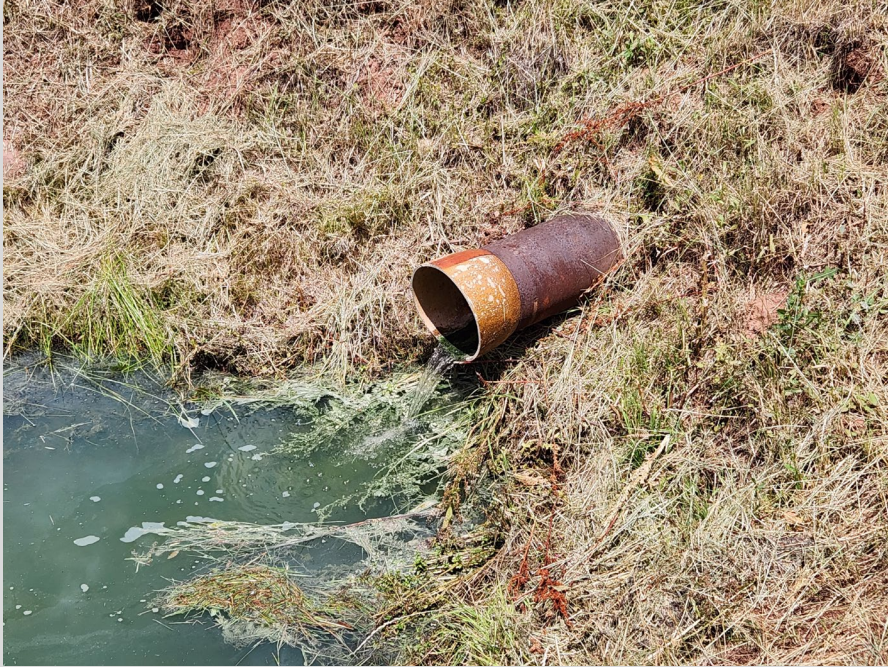
Outlet Outfall

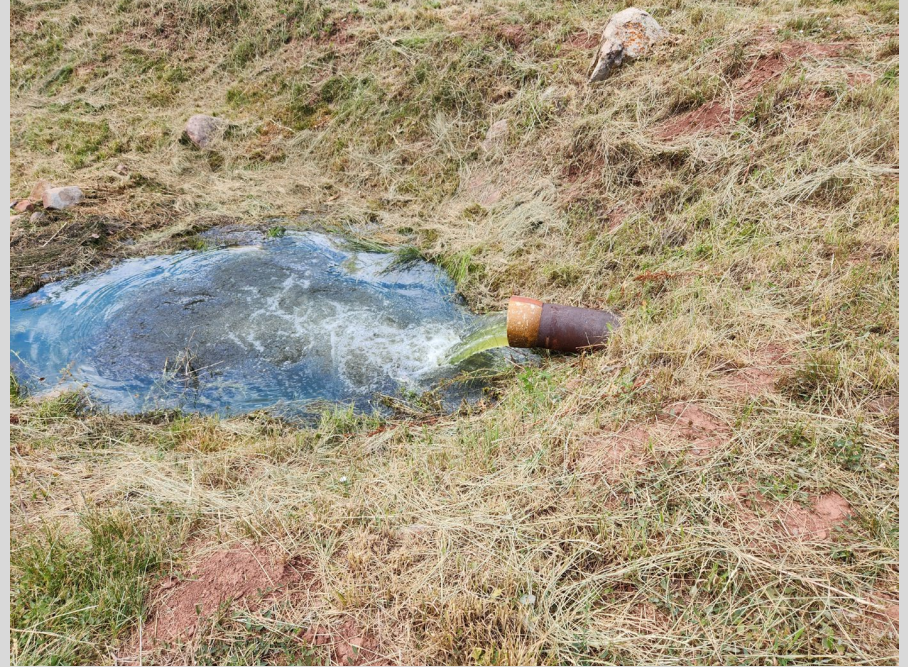
Gate was exercised with no problems encountered. (48) Leakage is always an issue following gate operation; however, this does not present any immediate dam safety concerns.

Exercising Outlet
