COLORADO
Division of Water Resources
Department of Natural Resources
Dam Safety Branch

When replying, please refer to:
TURNER DAM, DAMID 300113
Water Division 7, Water District 30

SUBJECT: 2025 Engineers Inspection Report

TURNER DAM

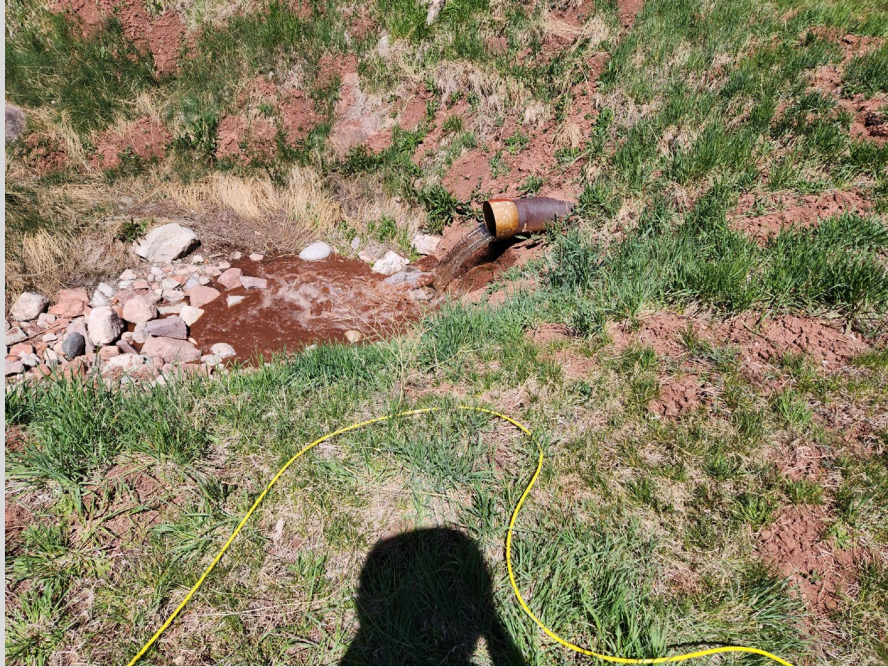
Exercising Outlet

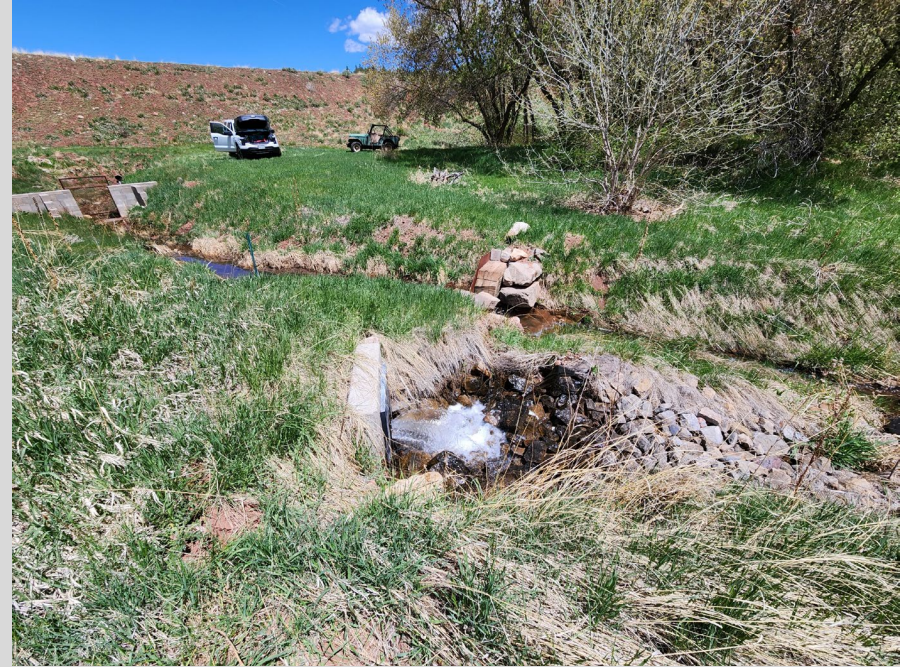
Diversion Outfall

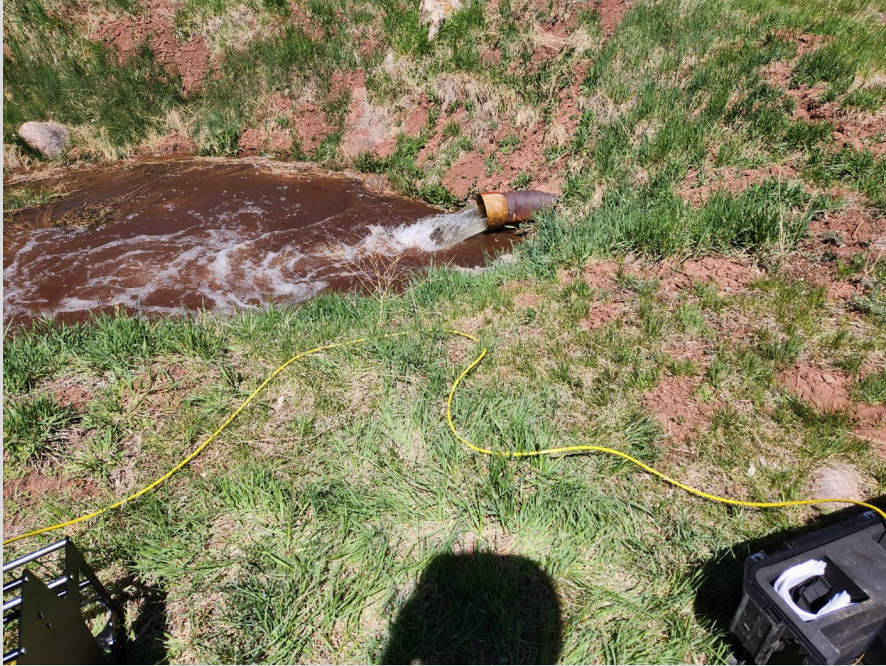
Exercising Outlet

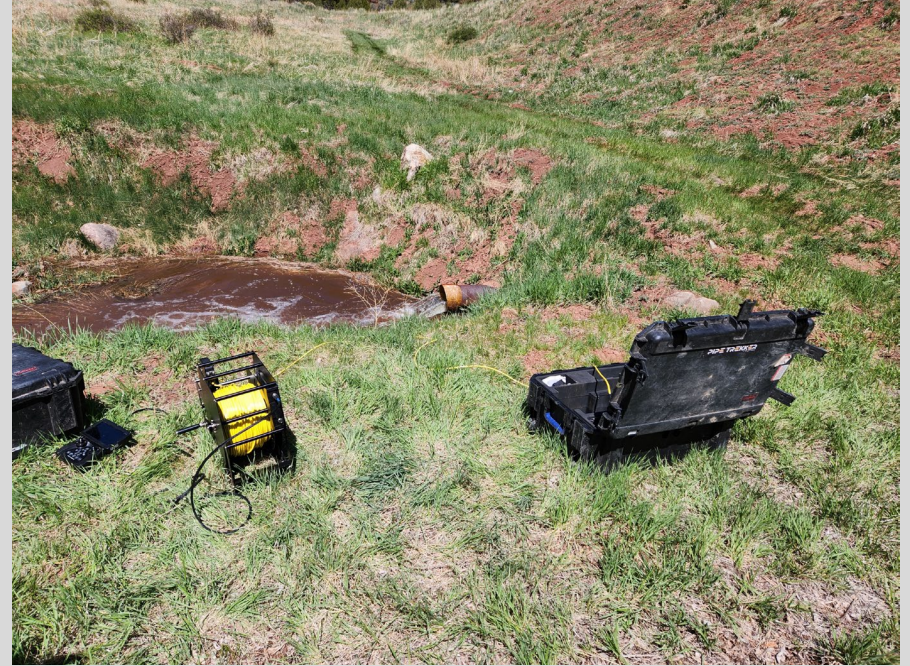
(121) The outlet was internally inspected using the State's pipe crawler. Photos have been appended to this report. The CIPP liner (impregnated felt; steam-cured) appears intact where observable. Most of the conduit is inundated due to sagging/bellying under the load of the embankment. Water is ponded above the springline at about ten feet upstream of the outfall. At around 110 feet upstream, there is a free water surface above the springline, and around 120 feet, there is a considerable grade change. The liner exhibits some wrinkling, most prominently from 140 feet to the intake. (48) There is considerable leakage at the elbow/gate, but the exact source(s) could not be determined. During the 2013 rehab, a 20-10C slide gate was retrofitted to the intake. The vent penetration, the mechanical upstream liner restraint, and the epoxy-repaired folds in the liner are all in the vicinity of the leakage. During the inspection, we attempted to adjust the gate to limit leakage while viewing with the crawler, but were unsuccessful.

Preparing to Inspect Conduit Internally

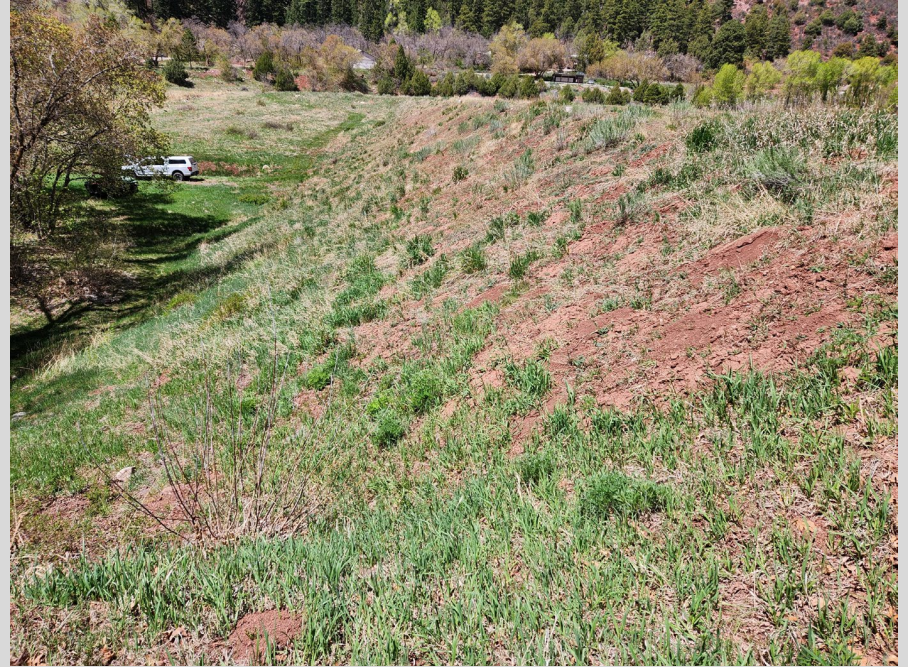
Vegetative cover has improved over the years; however, there are still some large areas of exposed soil primarily on the upper slope.

Downstream Slope from Left End

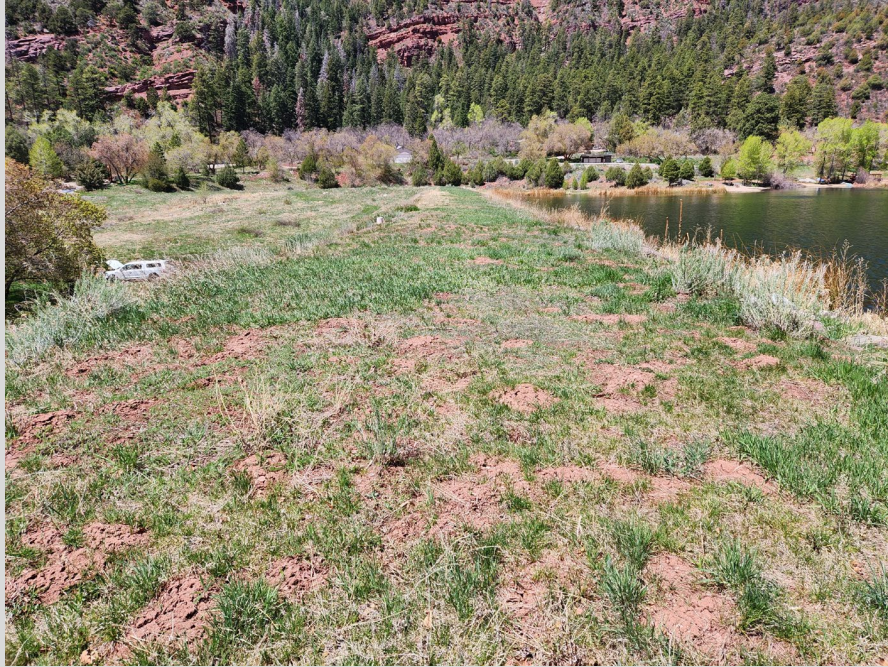
Crest

No changes or concerns noted.

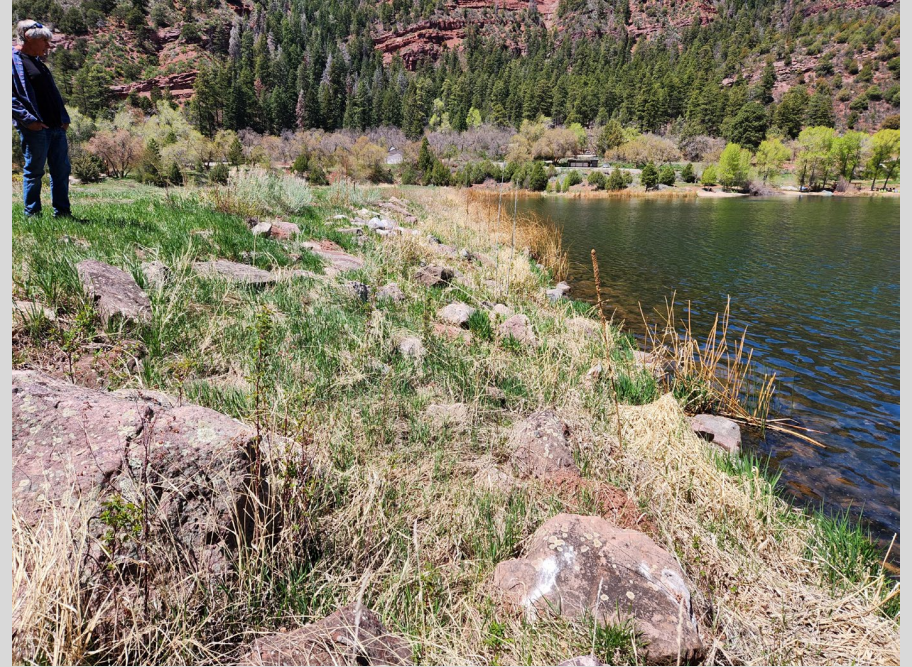
Upstream Slope

No changes or concerns noted.

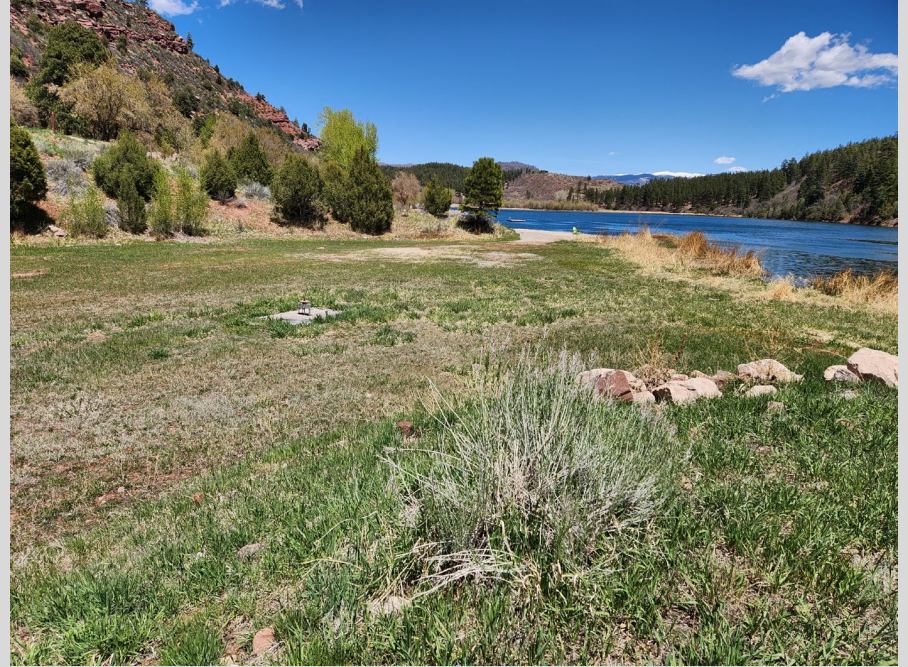
Spillway

The spillway is unobstructed and in good condition.

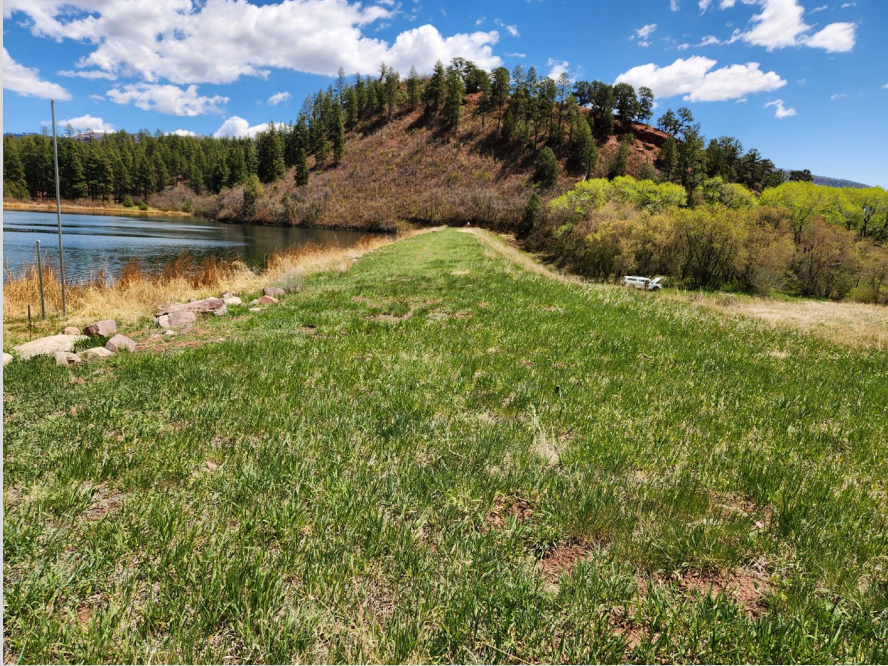
Crest from Right End

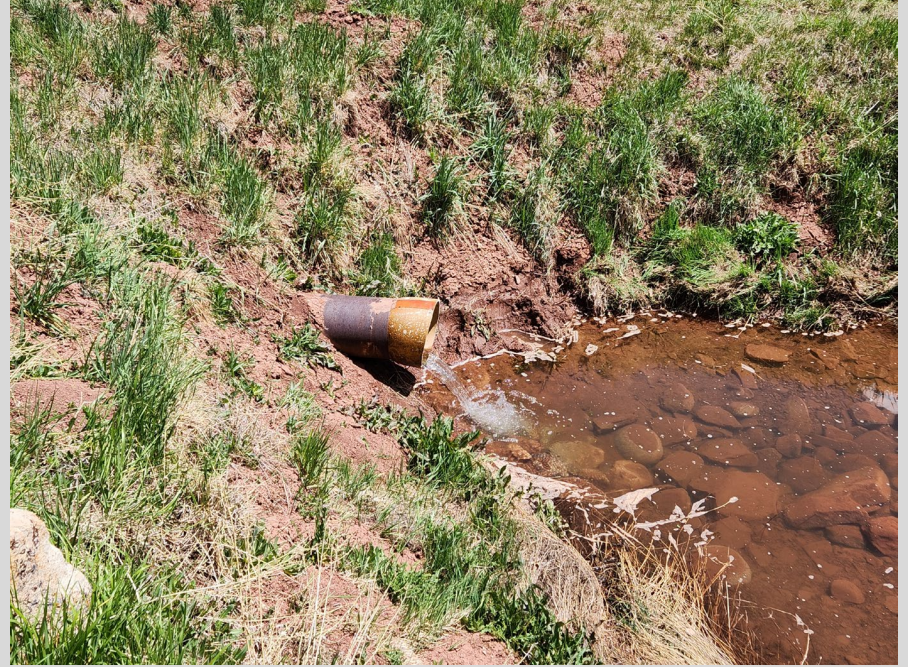
Outlet Following Inspection

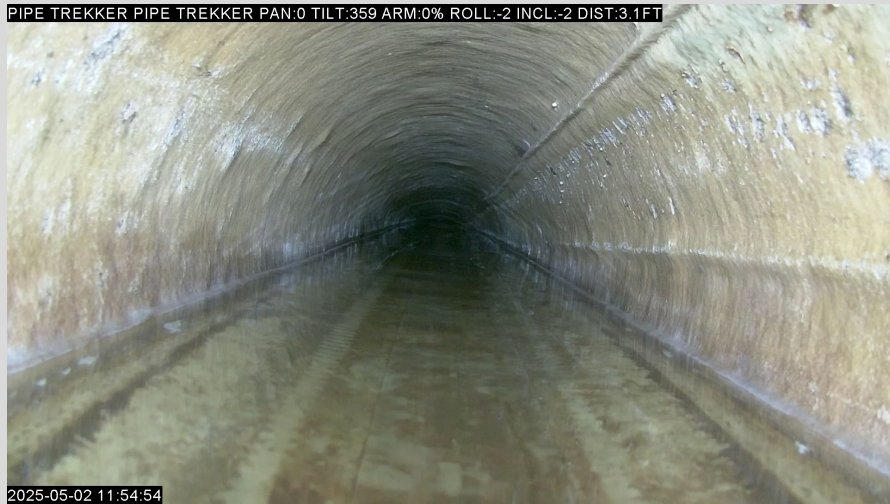
CIPP Line WSP from Near Outfall

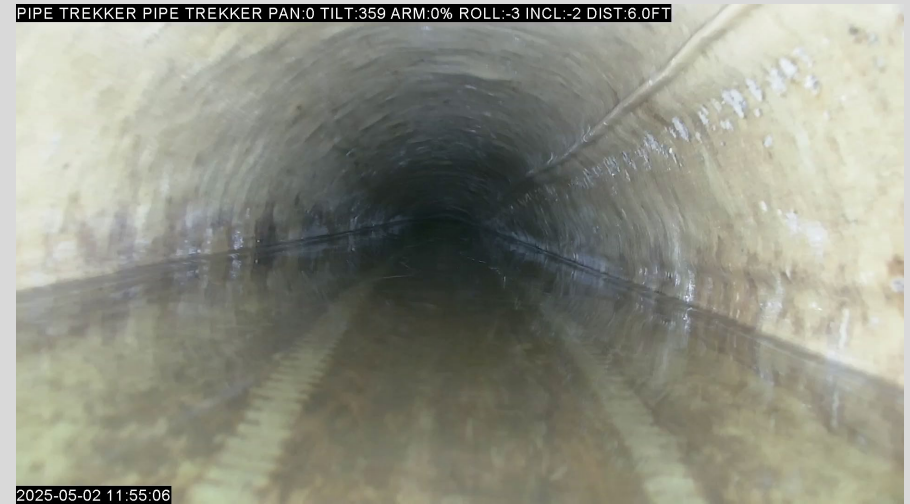
6 Ft. – Note Wrinkle at 2 o'clock

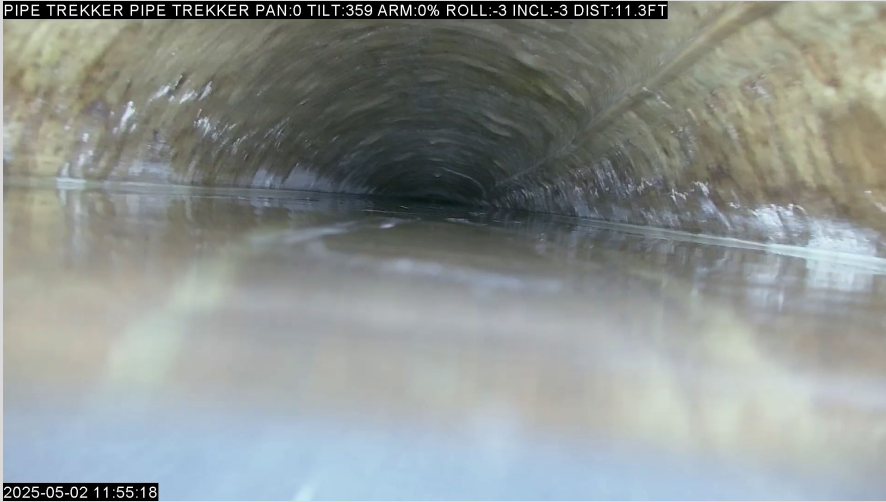
11.3 Ft. – Incline -3 deg., Poned Water to Spring Line

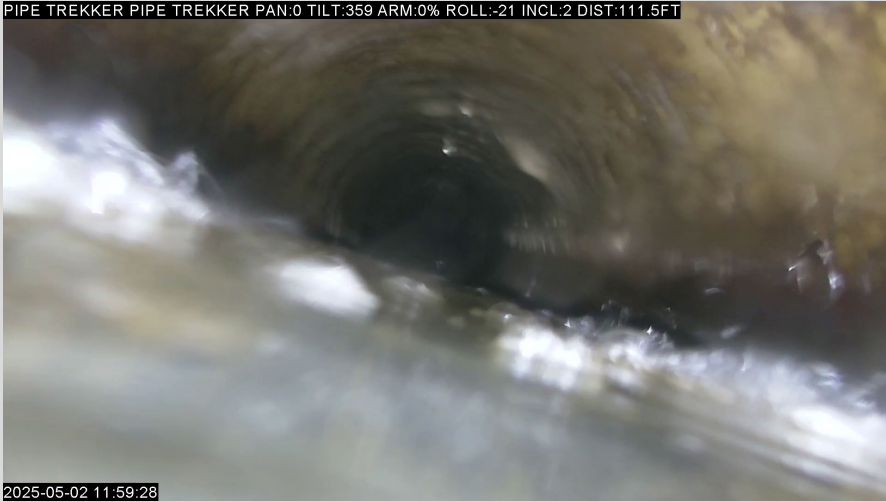
111.5 Ft. – Incline 2 Degrees Camera Out of Water

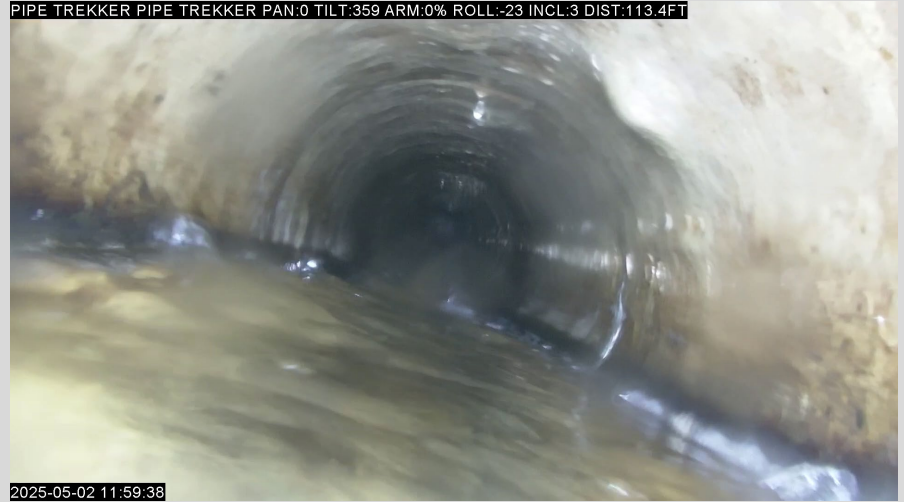
113.4 Ft. – Protrusion in Liner at 1 o'clock

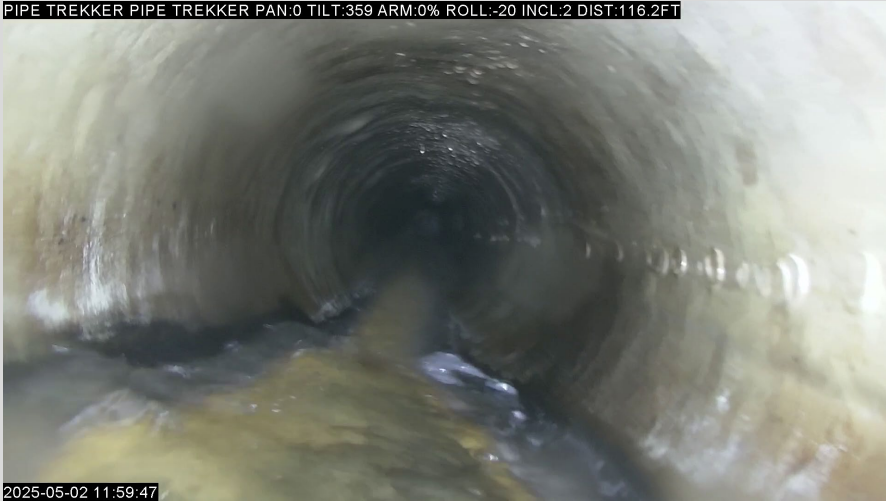
116.2 Ft. – Grade Change

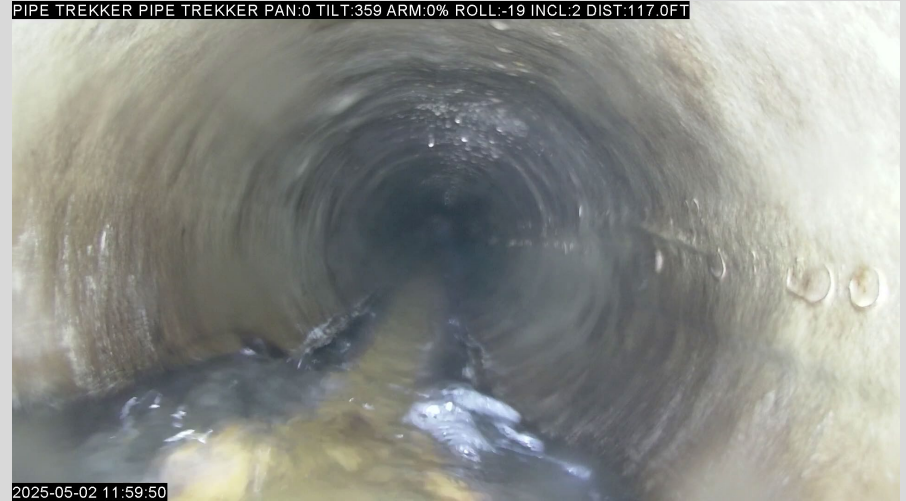
117.0 Ft. – Hydraulic at Grade Change

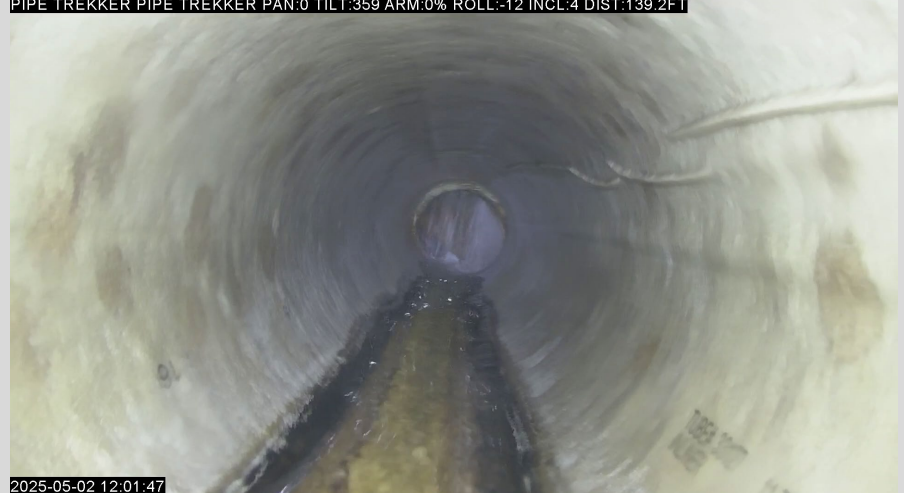
139.2 Ft. – Note Winkles at 2 o'clock

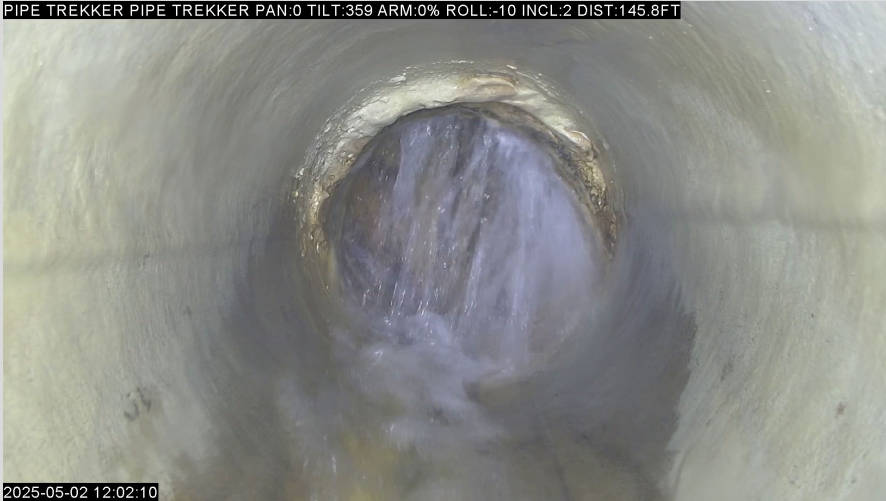
Elbow – Note Leakage

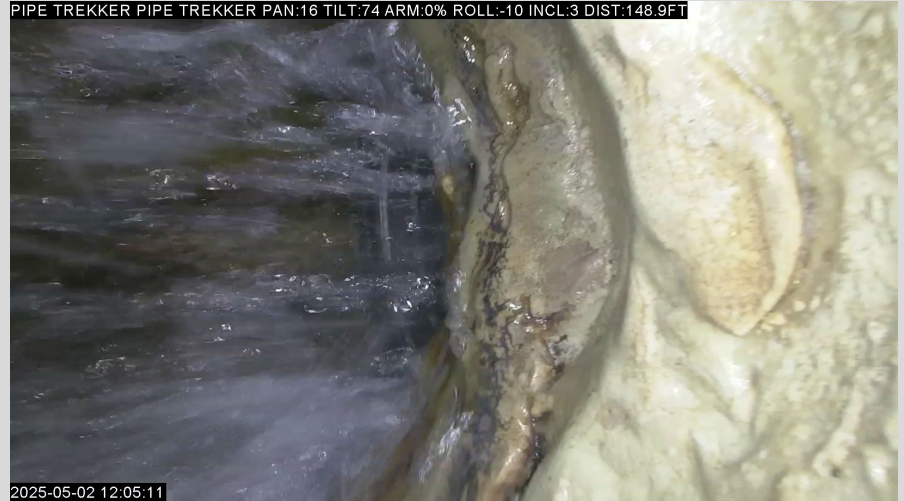
Leakage at Elbow – Epoxy Repairs to Liner During 2013 Install
